**Flood Control Project Maintenance  
Levee Inspections**

**Fall 2011 Levee Maintenance Deficiency Summary Report**

**Sacramento River Basin**

**Reclamation District No. 0817 Carlin**

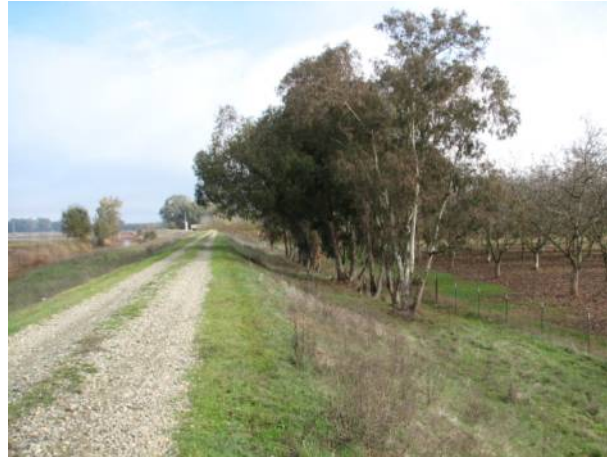
Levee Mile Report Line	1
Start Levee Mile	0.05
End Levee Mile	3.79
Location	Land Side
Category	Earthen Levee
Item	Vegetation

This photo shows the landside vegetation at levee mile 2.91.

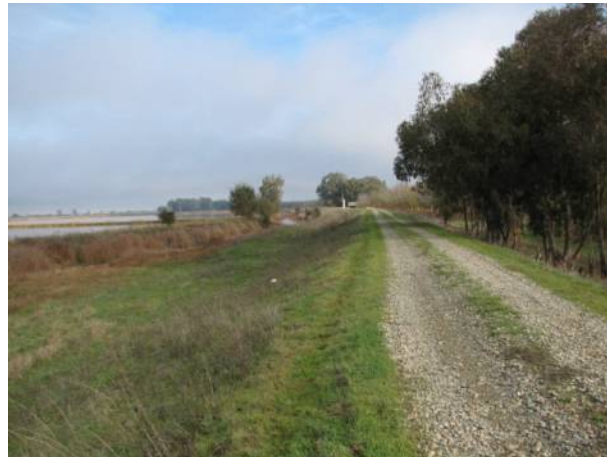
Levee Mile Report Line	2
Start Levee Mile	0.05
End Levee Mile	3.79
Location	Water Side
Category	Earthen Levee
Item	Vegetation

This photo shows the waterside vegetation at levee mile 2.91.

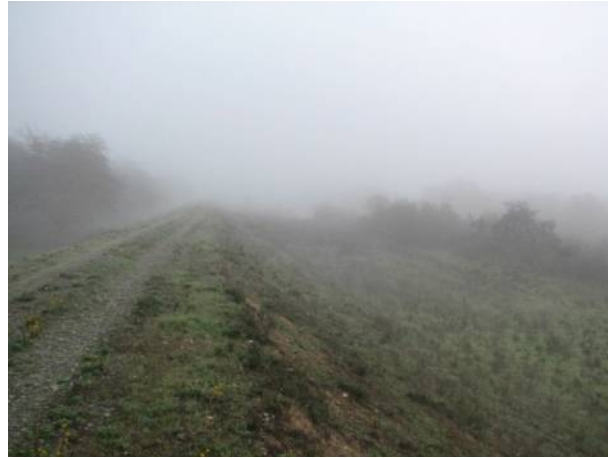
Levee Mile Report Line	7
Start Levee Mile	2.06
End Levee Mile	3.84
Location	Water Side
Category	Earthen Levee
Item	Vegetation

This photo shows the waterside vegetation at levee mile 2.69.

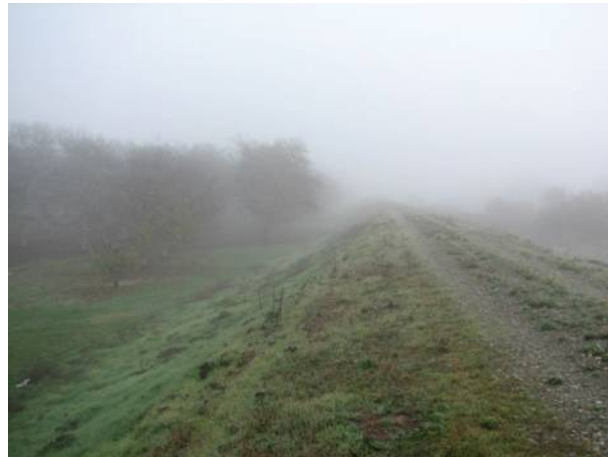
Levee Mile Report Line	8
Start Levee Mile	2.06
End Levee Mile	3.84
Location	Land Side
Category	Earthen Levee
Item	Vegetation

This photo shows the landside vegetation at levee mile 2.69.

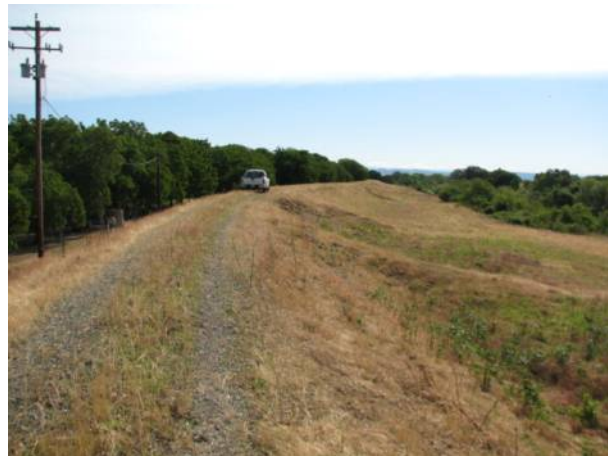
Levee Mile Report Line	9
Start Levee Mile	2.08
End Levee Mile	3.19
Location	Land Side
Category	Earthen Levee
Item	Slope Stability

Levee mile 2.08, this photo shows the slope is less than required, this is the downstream limit of the site, this is the waterside slope.

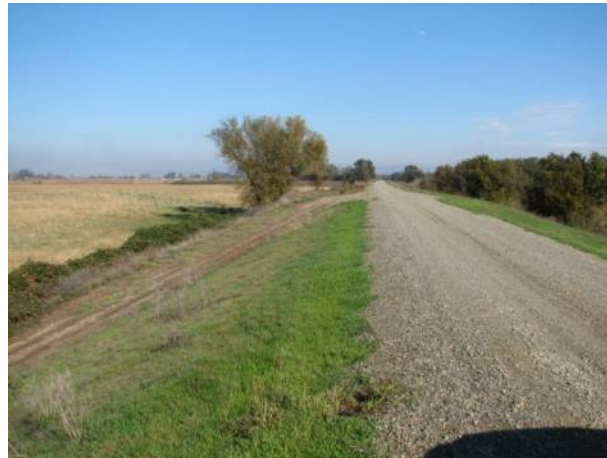
Levee Mile Report Line	1
Start Levee Mile	0.27
End Levee Mile	1.45
Location	Land Side
Category	Earthen Levee
Item	Vegetation

This photo shows the landside vegetation at levee mile 0.50.

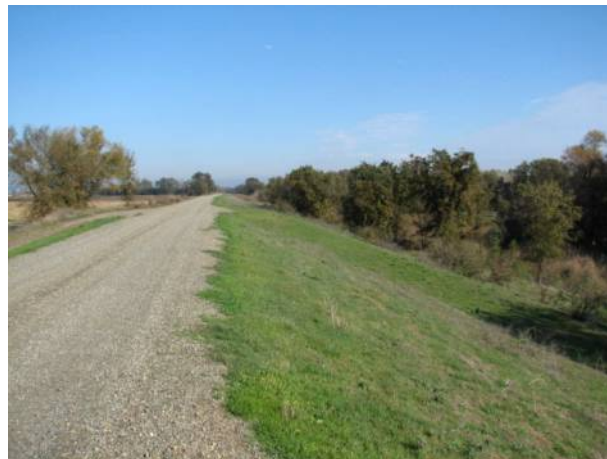
Levee Mile Report Line	2
Start Levee Mile	0.27
End Levee Mile	1.45
Location	Water Side
Category	Earthen Levee
Item	Vegetation

This photo shows the waterside vegetation at levee mile 0.50.

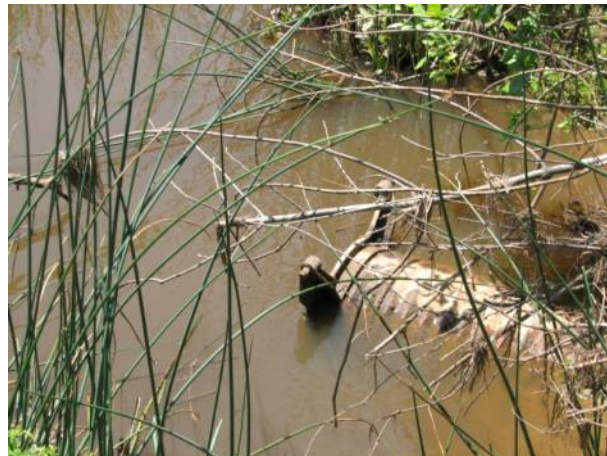
Levee Mile Report Line	5
Start Levee Mile	0.70
End Levee Mile	0.70
Location	Water Side
Category	Interior Drainage & Piping Systems
Item	Flap Gates

Levee mile 0.70, this is a photo of a missing flap gate at the waterside berm.

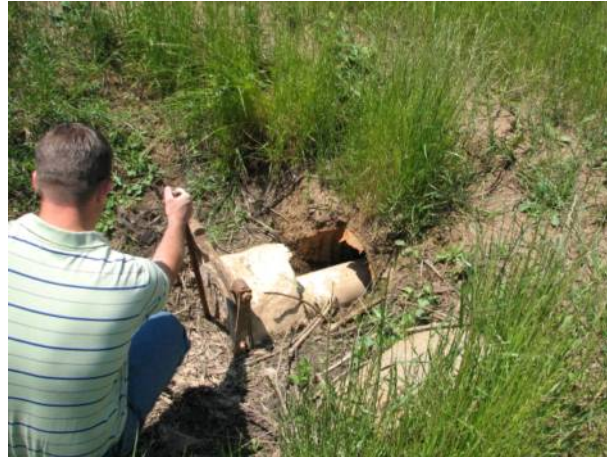
Levee Mile Report Line	8
Start Levee Mile	1.18
End Levee Mile	1.18
Location	Water Side
Category	Interior Drainage & Piping Systems
Item	Metal Pipes

Levee mile 1.18, this is a photo of a damaged pipe at the waterside berm.
